Manhole Inspection Summary

Manhole # S15WW_022MH

Insp Date: **4/3/07 10:50 AM**

Location Address: **REISTERSTOWN RD**

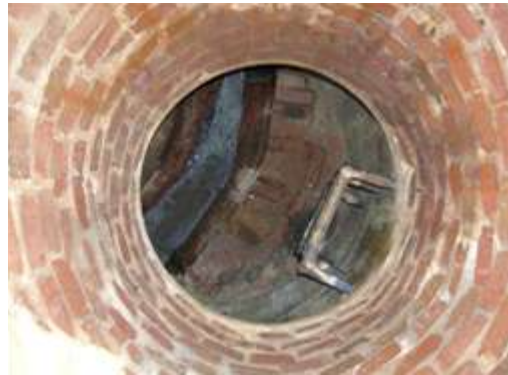
Top View

Adjustment and Corbel infiltration. Bench debris.

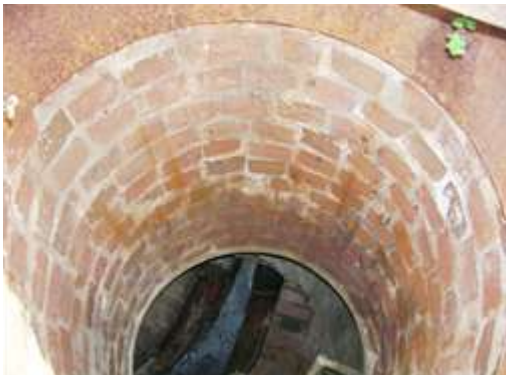
Defect

Adjustment infiltration.

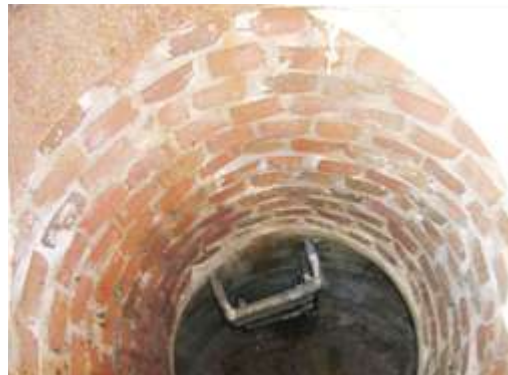
Defect

Adjustment infiltration - other side.

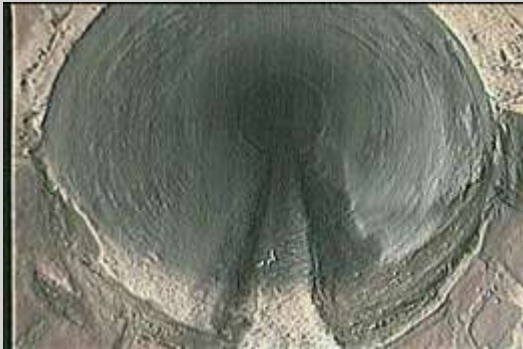
18 in. Circular Gravity Sewer Pipe Out @ 12 O'Clock

Deposits: ☐ None ☐ Mud ☐ Sludge ☐ Debris ☒ **Grease**

Silt Depth: **0** (in.) Deposits Extent: **Light**

Infiltration: **Evidence**

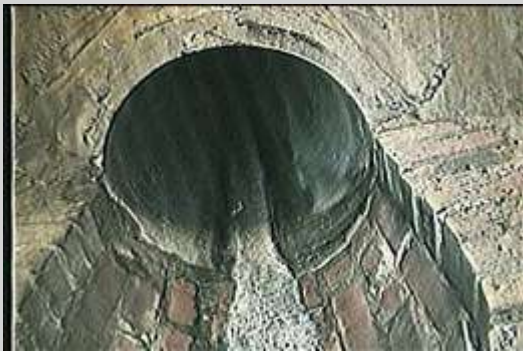
18 in. Circular Gravity Sewer Pipe In @ 7 O'Clock

Comments **The I7 pipe picture shows Channel deterioration.**

Condition: ☐ Sound ☐ Cracked ☐ Root Intrusion ☒ **Deteriorated** ☐ Leaks ☐ Debris

Deposits: ☐ None ☐ Mud ☐ Sludge ☐ Debris ☒ **Grease**

Silt Depth: **0** (in.) Deposits Extent: **Light**

Infiltration: **Evidence**
